## Restoration of historic dwelling on South Circular Road

*Project 3757: Residential - Restoration*

**69 South Circular Road**

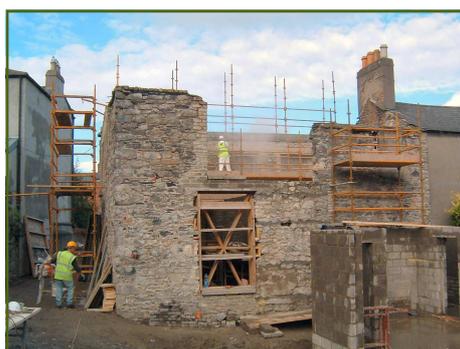
Cracked masonry was carefully stitched together to restore structural integrity.
